# Memorandum

**To:** Water District 34 2004 File/NOV Files  
**From:** Tim Luke  
**Date:** July 8, 2004  
**Re:** Field Visit and Review of Headgate and Measuring Devices

On June 24, 2004 I visited several diversions on Warm Spring Creek and Parsons Creek to check compliance with previously issued NOV's, consent orders and compliance letters. Several additional diversions were checked for flow measurement since many diversions and rights above Mackay Reservoir were shut off or regulated as a result of the Big Lost River being connected both above and below the reservoir. The following is a summary of my visit and inspections:

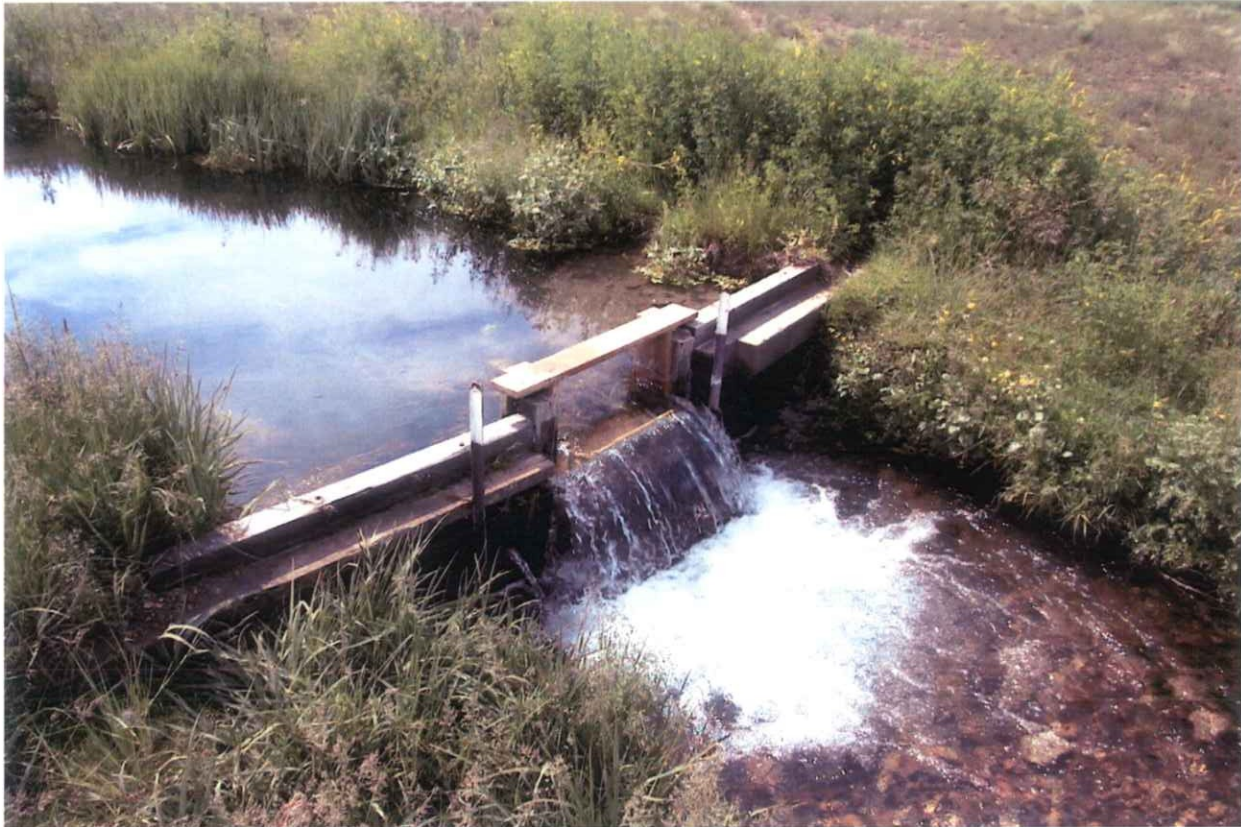
- 3) Stoecklein 1 Ditch (13124173): Diversion shut off/no flow in ditch.
- 4) Stoecklein 2 Ditch (13124175):
  - Weir in ditch just above road crossing has been re-installed. Weir is 2 ft. rectangular wier. Good level weir blade/crest, but no sharp side edges (wood frame only). Some leakage on both sides of weir. Weir generally appears improved over former weir, at least at the observed flow. Measured flow at 1.92 cfs.

Weir at Stoecklein 2 Diversion. 2 ft. Rectangular Weir

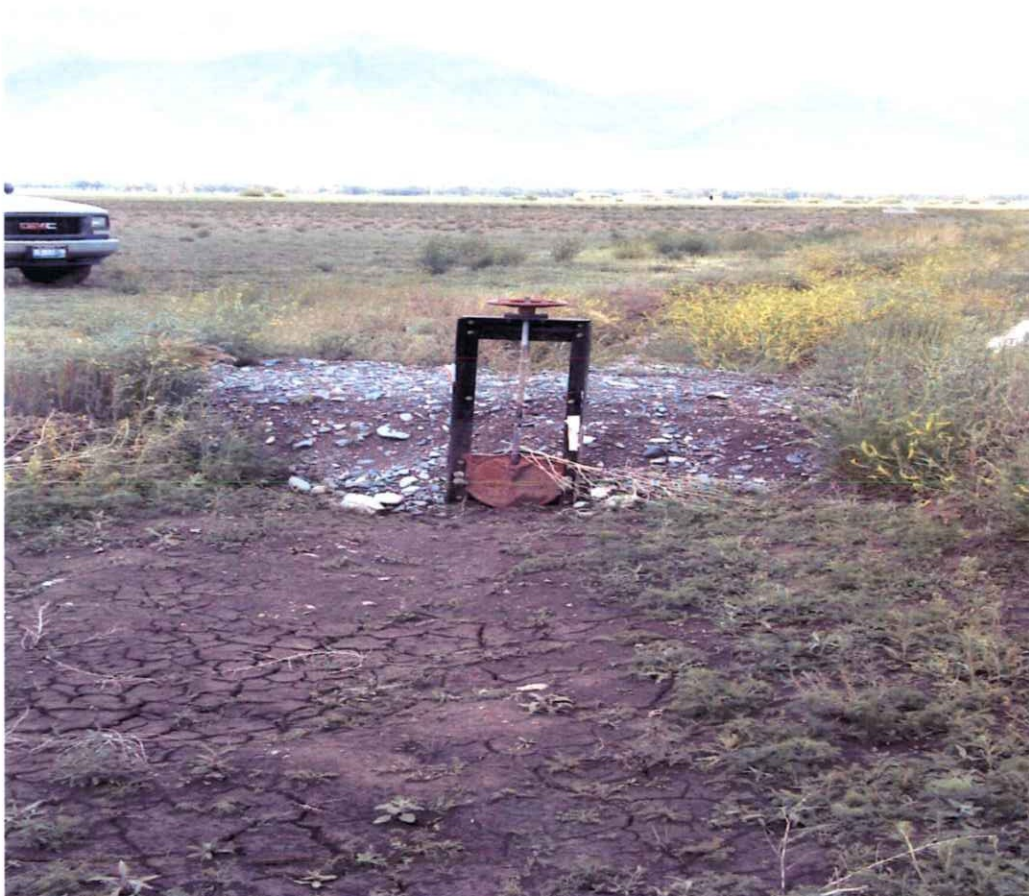
- 5) 6X Ranch 6 Ditch (13124100): Headgate closed/no flow in ditch
- 6) Stoecklein 4 Diversion and Ditches (13124180):
  - New headgate installed on north ditch or north side of creek. No diversion of water. Ditch somewhat filled in above headgate

Stoecklein 4 Diversion, ditch on north side of creek to pond: New Headgate with culvert.

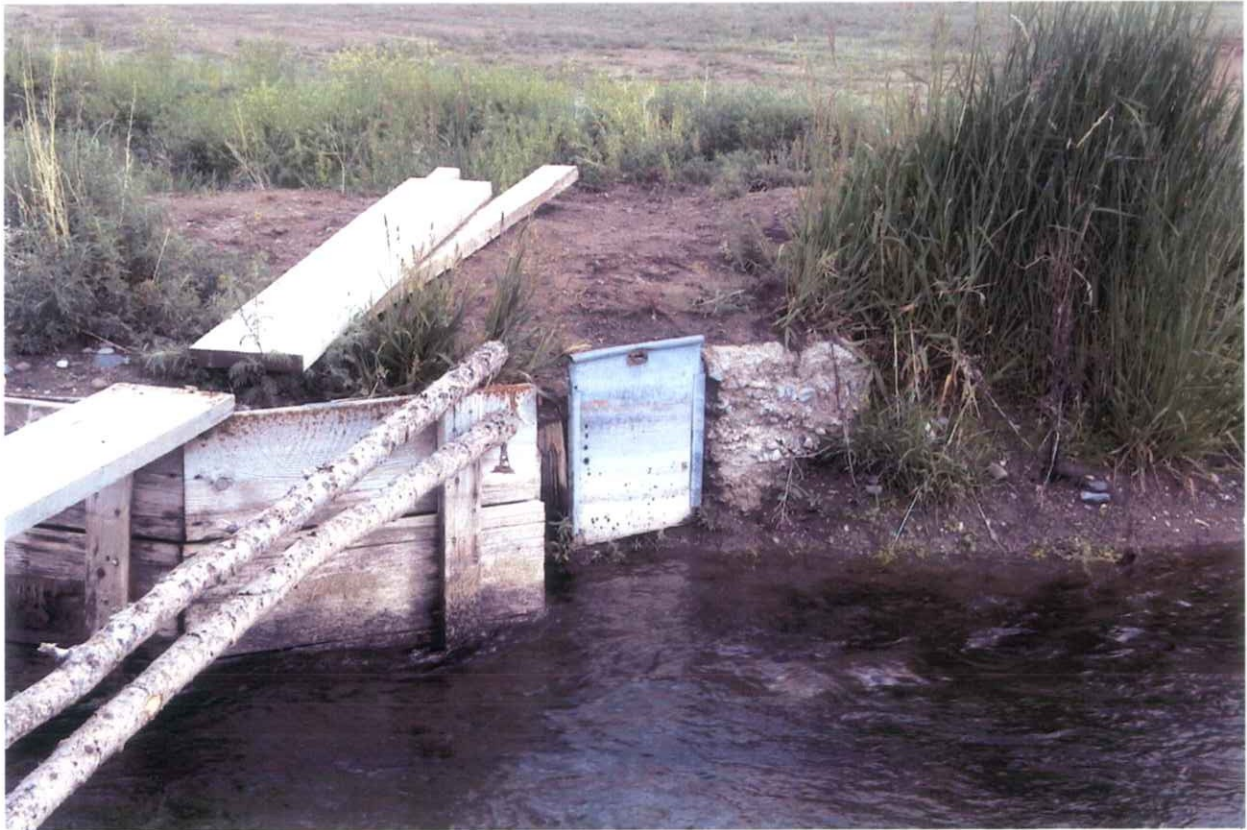
with 4 to 5 holes drilled on side for locking. The gate can be locked shut with a single padlock.

Stoecklein 4 Diversion: Headgate and ditch on south side of creek. Slide gate has holes for lock. Gate can be fully closed and locked.

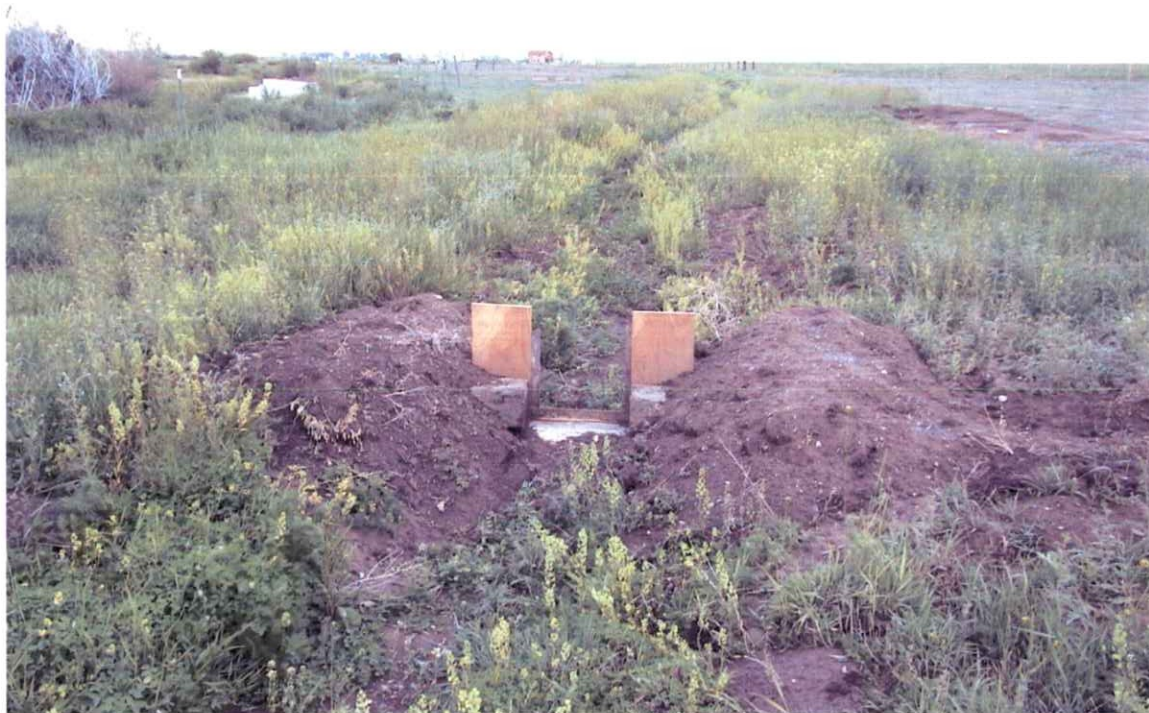
- New weir installed in ditch on south ditch/south side of creek. Weir is standard rectangular weir with 1.35 ft. width or weir crest. Installation looks acceptable. Headgate is slide gate

Stoecklein 4 Diversion, ditch on south side of creek with 1.35 ft rectangular weir (view looking down ditch/upstream of weir)

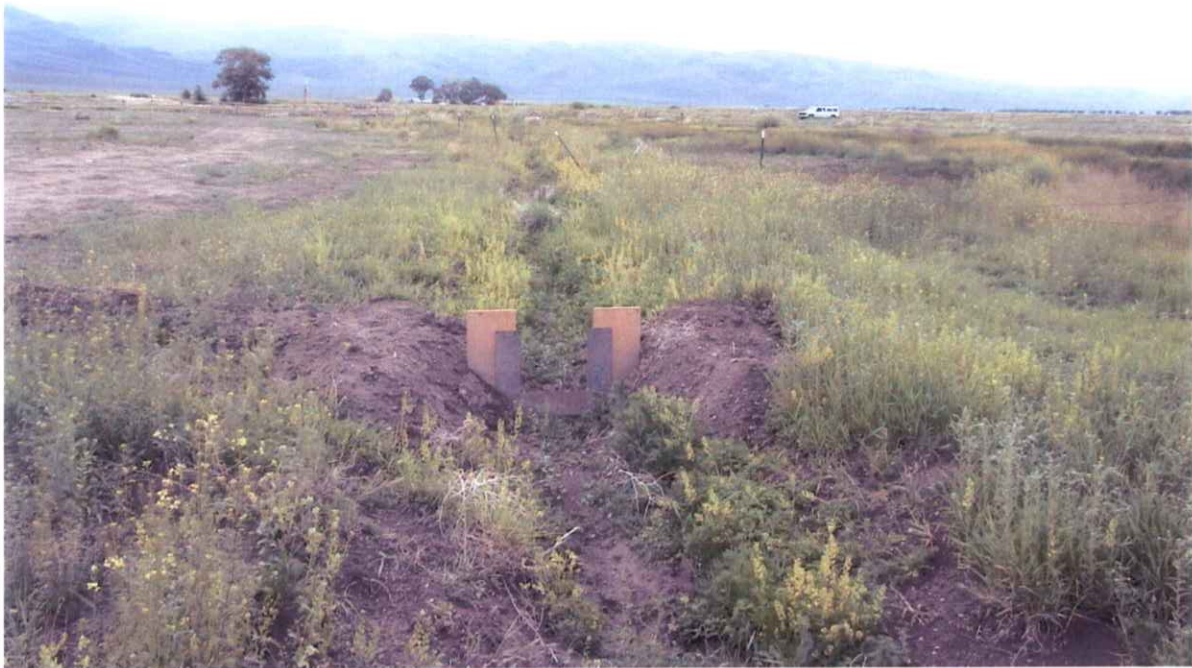
Stoecklein 4 diversion south ditch weir, view from downstream of weir/looking up ditch.

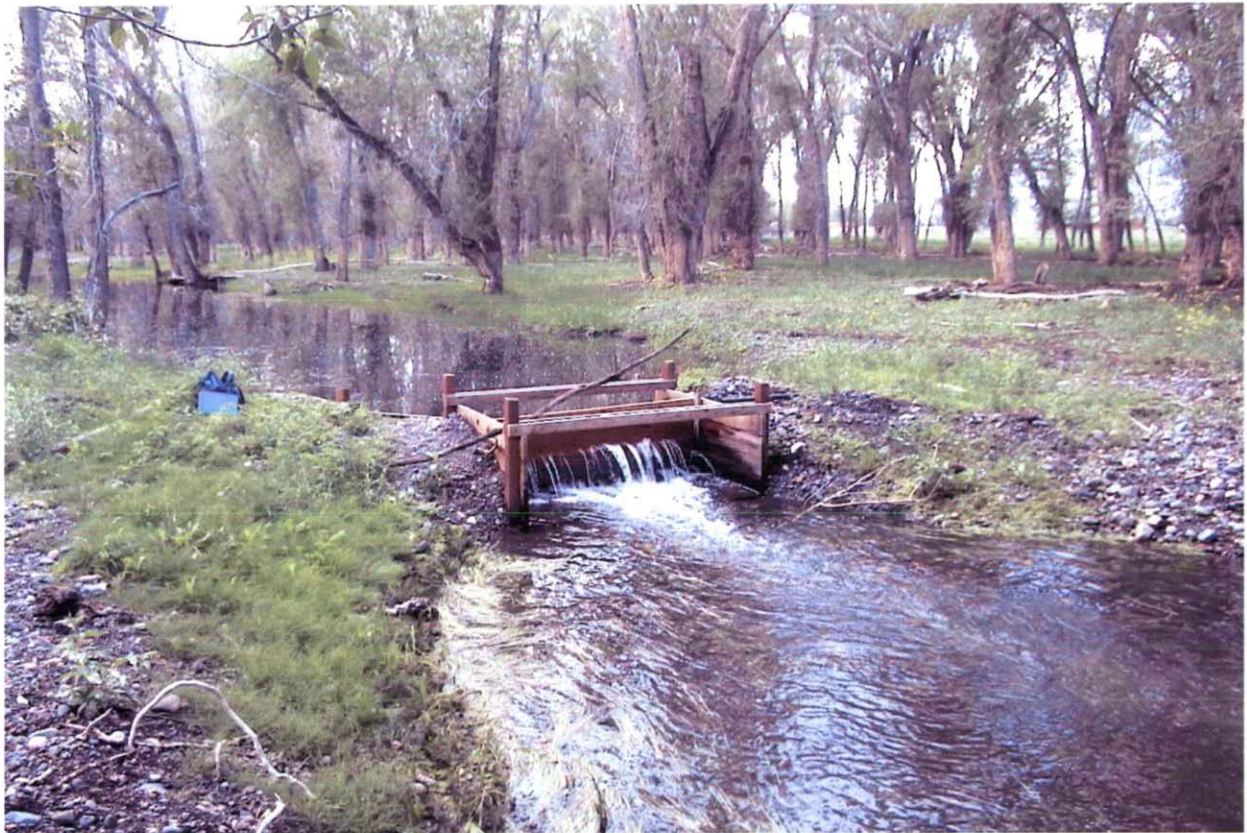
- Observed that one of the installed check boards had a level steel plate or weir blade attached to top to provide weir measurement. Watermaster said this is used as both top check board and for weir measurement. Depending on flow approach to box and flow over weir board/plate, this is probably acceptable for measurement purposes, and can be used as a suppressed rectangular weir.

Zollinger 2 Diversion: boards installed in structure for both control and measurement.

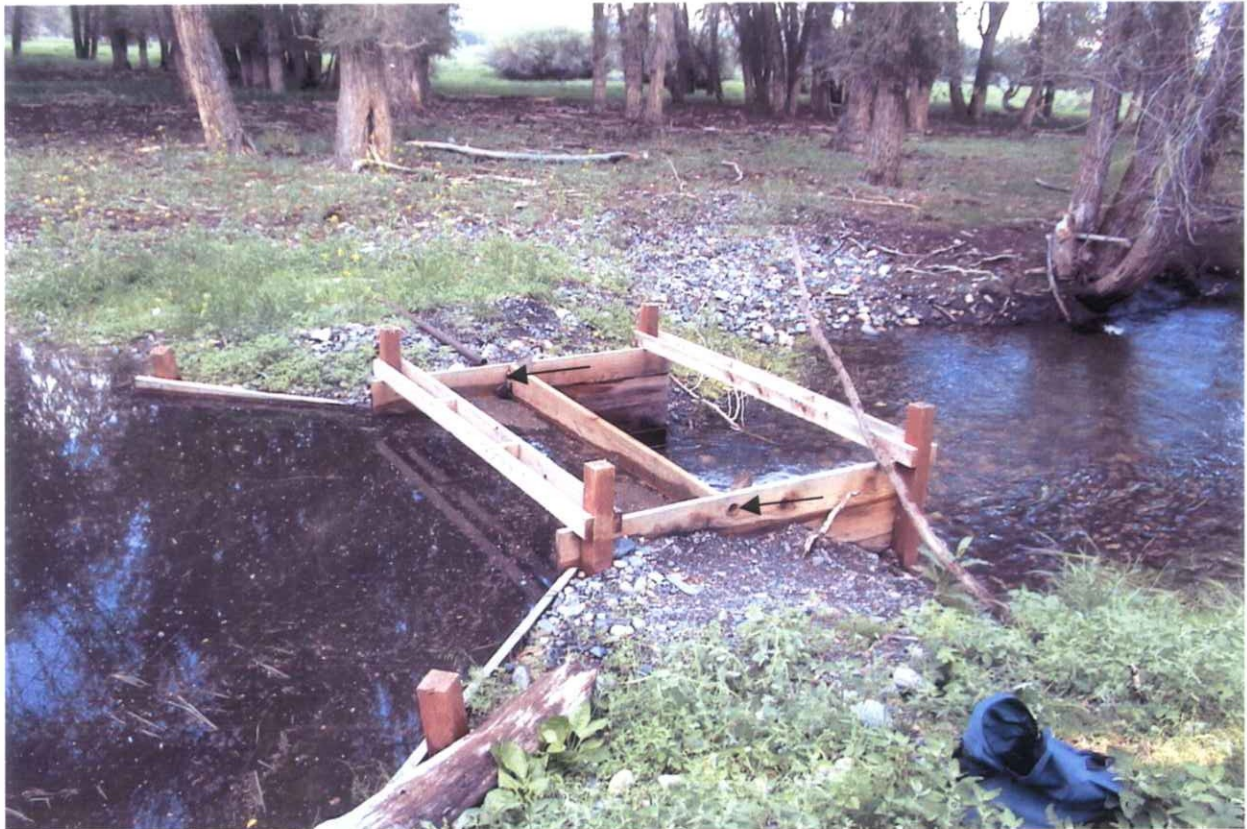
- Observed a round metal bar on the ground on other side of ditch and box that can be inserted through holes at top of stop log grooves and locked so that boards cannot be removed. Could not examine bar or determine how bar is locked but I believe or assume there are holes drilled at ends for installation of locks. At time of visit, boards could not be locked because boards were installed to top and bar could not be inserted through holes.

Zollinger 2 Diversion: boards in structure to shut off flow. Arrows show location of holes where bar can be inserted for locking. At this stage or water level, bar cannot be inserted because board is inserted in the top of the structure to prevent flow down ditch. See bar on ground on other side of structure.

- Recommend inspection of this ditch and structure again when water is being diverted to check functionality and accuracy of weir, as well as ability to lock the check boards in place when necessary. Users should be notified of concern about inability to lock device at certain times and to control leakage.

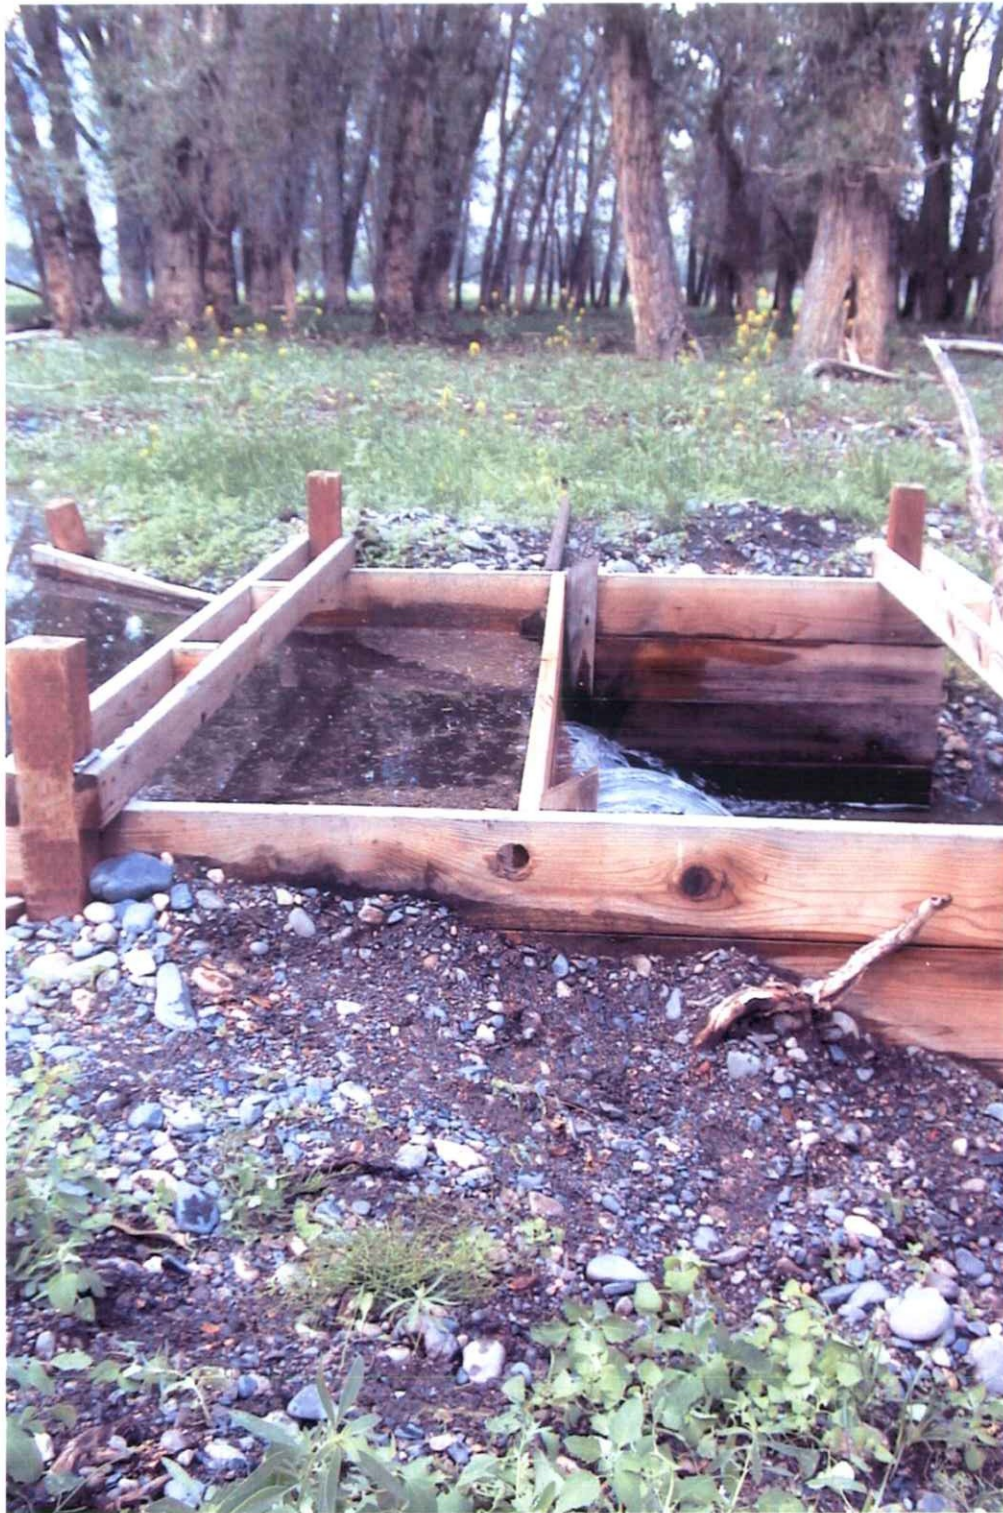
- Owners modified wooden timber structure from last year so that check boards can be installed vertically in box. Check boards were installed to the top of the box at time of visit in order to completely shut flow off to ditch below the box, but there was some significant leakage through the boards. Estimate leakage up to 0.5 cfs (about 25 inches). Owners drilled a hole on both sides of box and at top of stop log grooves.

Zollinger 2 Diversion: Close-up view of structure. See holes and bar for locking. Top board prevents insertion of bar. Note significant leakage through boards. One of the boards has a weir an installed metal weir blade for improved measurement.
